## Bulletin 3.11.2009 – Correct ppg harness setting / *Správné seřízení ppg postroje*

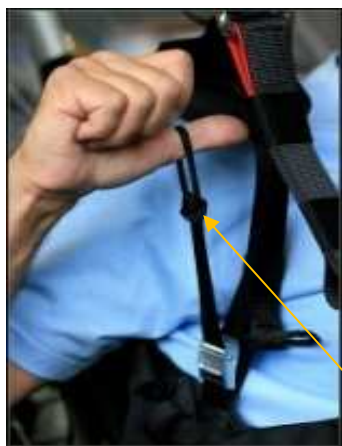
Optimum setting / *optimální seřízení*

The belts must be set symmetrically to avoid higher stressing one side of the Back bend pipe by the pilot's weight.

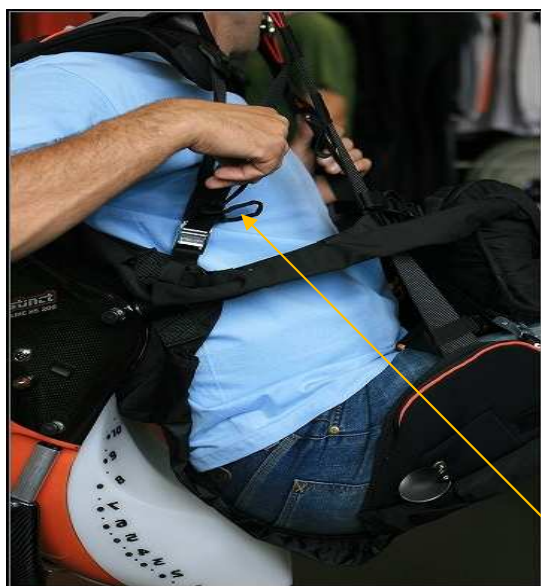
Dear customers – Nirvana paramotor owners. As there appeared several damaged Back bend pipes (Part No. 010908) (the part, where harness is joined to paramotor skelet), please check your side harness belts setting. These allow you to set the depth of the sitting position. If these belts are too loose (your bottom is touching the petrol tank) or belts are set unsymmetrically, then it can cause stressing one side of the Back bend pipe during the flight and then its permanent damage.

Incorrect setting, the strap is too loose  
*Nesprávně seřízeno, popruh je příliš povolený*
